MINE SUBSIDENCE IN ILLINOIS: FACTS FOR HOMEOWNERS

ENVIRONMENTAL GEOLOGY 144 1993

Department of Energy and Natural Resources
ILLINOIS STATE GEOLOGICAL SURVEY

**Prepared for
ILLINOIS MINE SUBSIDENCE INSURANCE FUND**

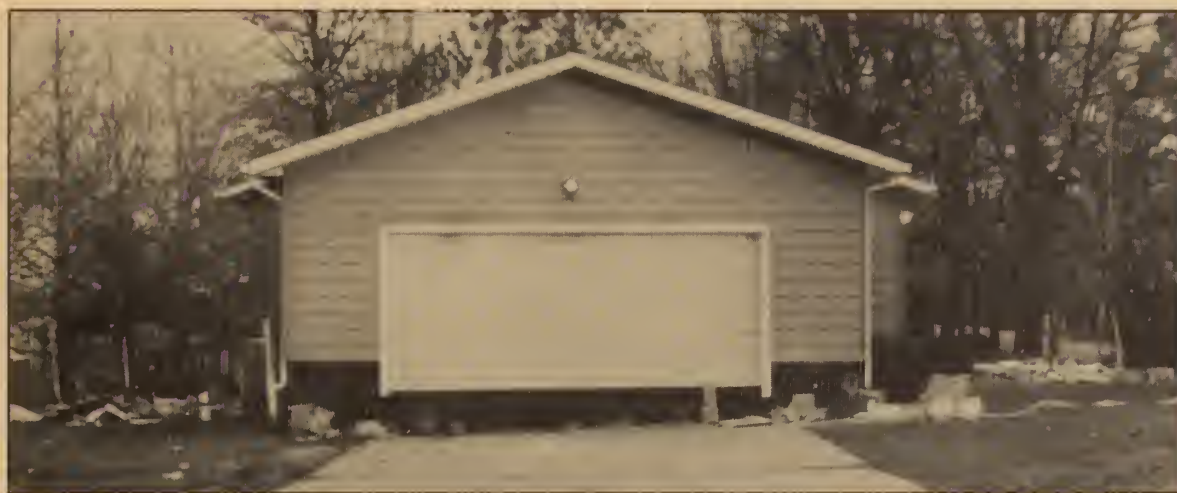
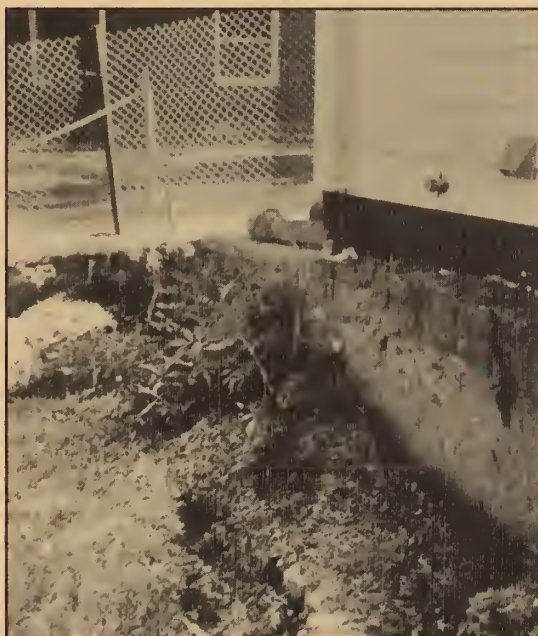
Cover photos (above) House affected by a sag subsidence event from the collapse of an abandoned coal mine. House is being maintained in a level position as ground moves downward. (below) Pit type subsidence event occurring next to the foundation of a home in southwestern Illinois. This event is the result of the collapse of a shallow abandoned coal mine.

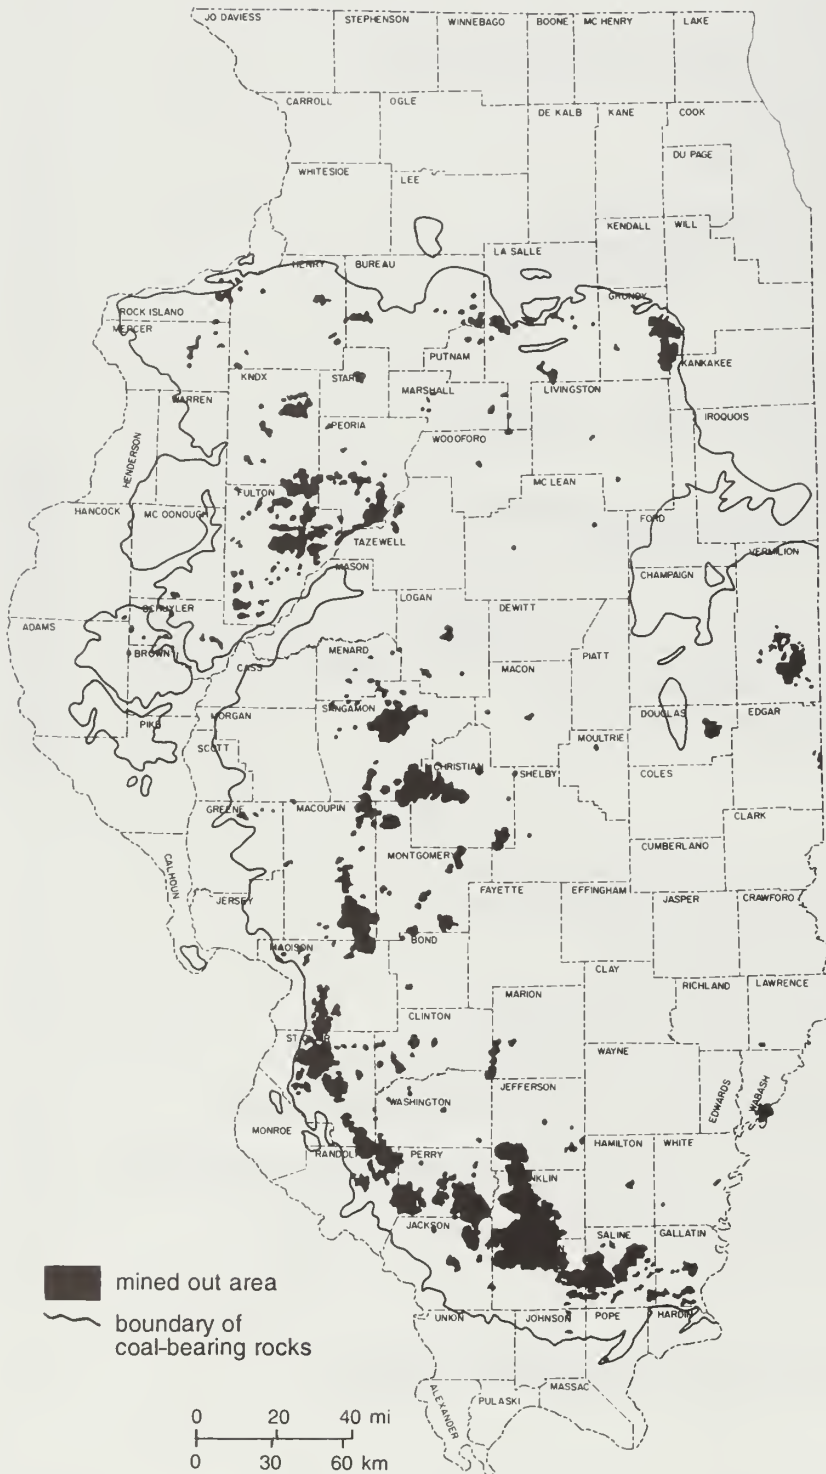
Figure 1 Areas where coal has been mined in Illinois.

The total acreage of abandoned underground coal mines (fig. 1) far overshadows acreage undermined for all other commodities (table 1). About 178,000 acres of residential and other built-up areas can be found close to

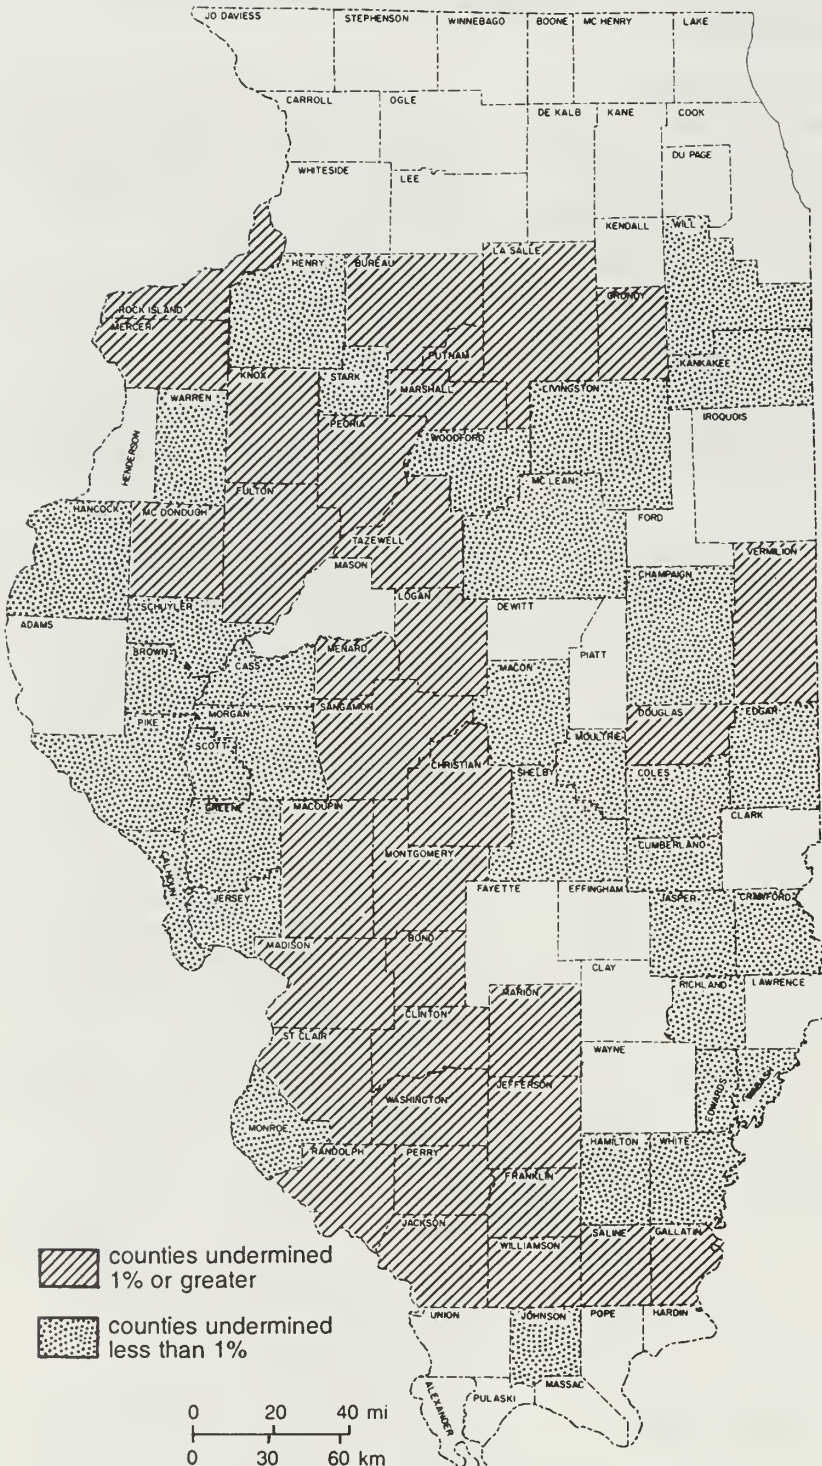
Figure 2 Counties of Illinois undermined for coal. Counties with undermined areas of 1% or more are automatically included in the mine subsidence insurance program.

Figure 2 shows how extensive underground coal mining has been in each county. Counties with more than

Homeowners in counties where 1% or more of the land has been undermined (fig. 2) — a significant exposure to mine subsidence — will automatically have subsidence insurance added to their policies when issued. Anyone refusing coverage will be asked to sign a waiver.

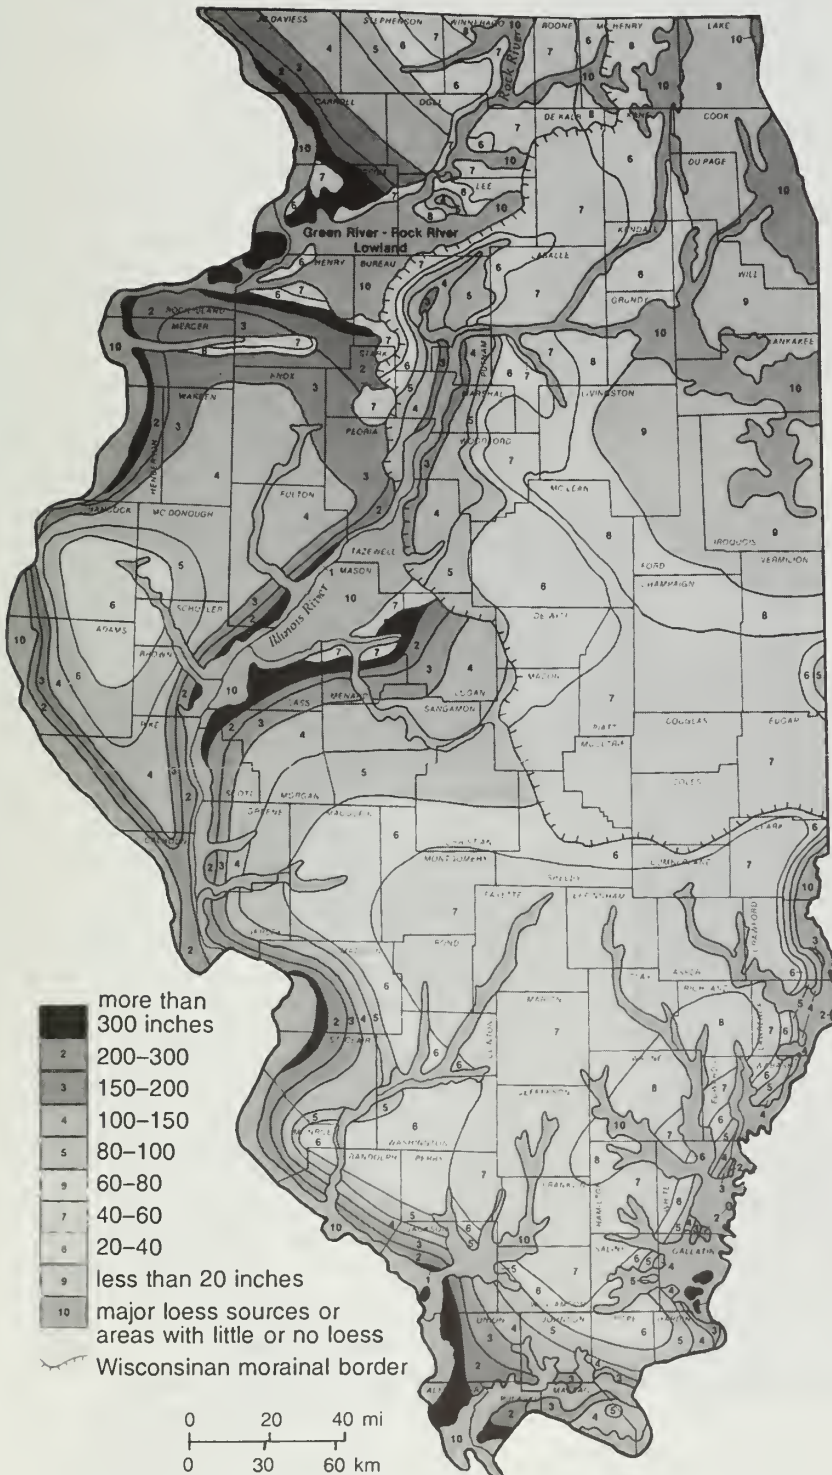
Figure 3 Total loess thickness in Illinois (Fehrenbacher et al. 1986).

Glacial materials range from less than 10 feet to more than 200 feet thick over the areas mined in Illinois. A layer of windblown silt, called loess, blankets most of the surface of the state, including coal mining areas. Loess ranges from less than 2 feet to about 25 feet thick (fig. 3), except for a part of southwestern Illinois where it may be as much as 100 feet thick. Beneath these surficial deposits is bedrock consisting of flat-lying or gently dipping sequences of shale, coal, claystone, limestone, and sandstone (fig. 4). The layer below most Illinois coals is a soft clay, called underclay.

Piping into a sewer line develops over many years. The ground may sink or collapse, forming depressions that have been mistaken for mine subsidence. Loess is highly susceptible to piping. (Figure 3 shows the thickness and distribution of loess in Illinois.)

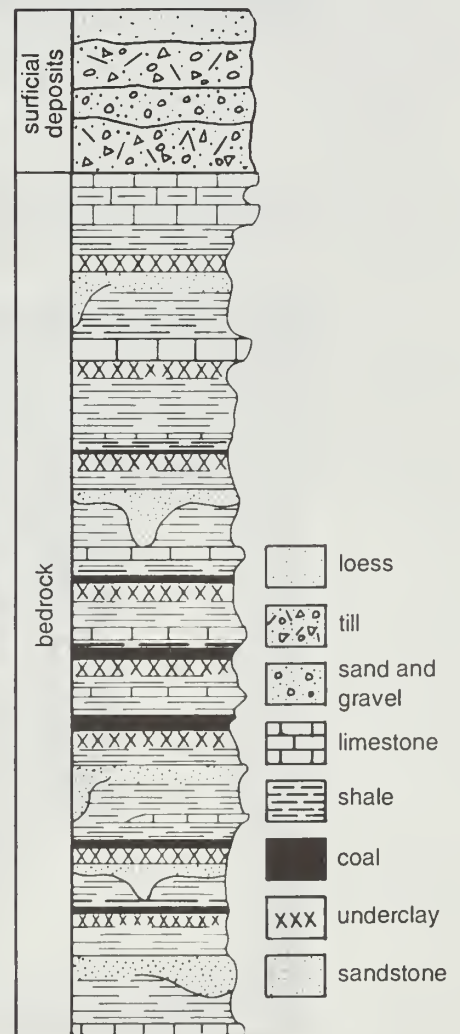
Figure 4 Generalized geologic column representing layers of surficial deposits underlain by layers of bedrock that might be present in a typical undermined area.

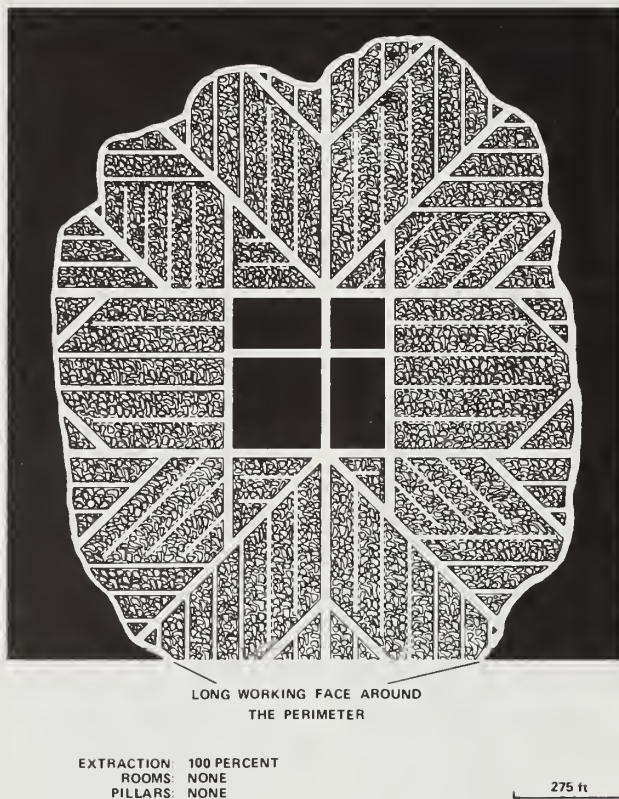
Figure 5a Early longwall mine. Coal was removed from center (shaft) outwards along continuous perimeter. Voids were backfilled with rock support (after Andros 1914a).

High-extraction methods (fig. 5) mine almost all the coal in a localized area. They always result in the surface subsiding above a mine within several days or weeks after the coal has been removed. The sinking or subsiding of geologic materials lying over the mined-out area will continue for years, although it will diminish rapidly after a few months. Once subsidence has decreased to levels that no longer cause damage to structures, the land can usually be developed. In early longwall mines (fig. 5a), workers maintained the haulageways (entrances) by leaving areas of stacked rock, wooden props, and rock-filled wooden cribs to replace the support lost by the removal of coal. The mine roof, then the overlying bedrock and earth, settled onto the stacks of rock. When this occurred, a few feet of subsidence resulted at ground surface.

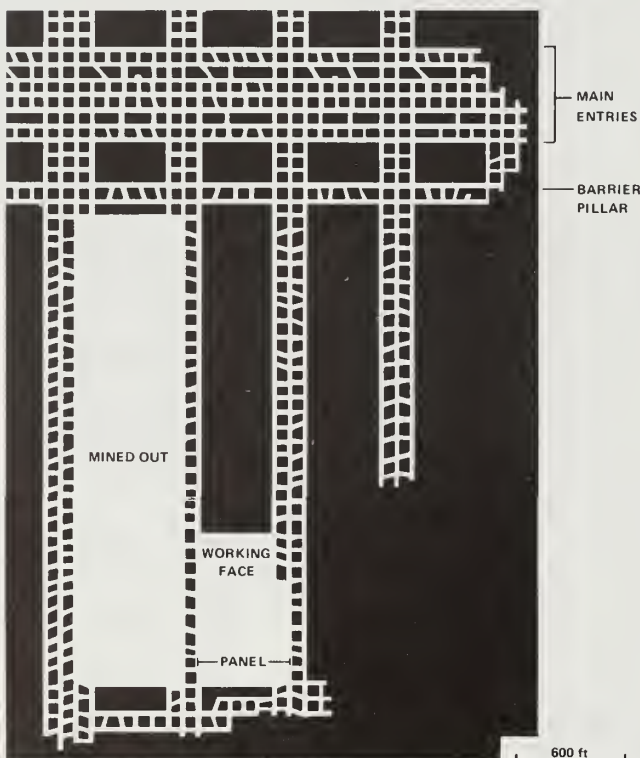
Figure 5b Modern method. General development plan for high extraction retreat and longwall mining. See figs. 5c and 5d for detailed view (after Hunt 1980).

Modern high-extraction systems are designed to achieve a high rate of production (figs. 5b-d). Using the high-extraction retreat method, miners remove as much coal as possible in a small area until the roof starts to collapse; then they retreat to the next area. Using the modern longwall method, workers mine 100% of the coal along a straight working face beneath artificial roof supports. The mine roof collapses immediately behind the working face, causing 4 to 6 feet of subsidence. This amounts to 60% to 70% of the mined height of the coal seam plus any roof or floor materials that have been removed.

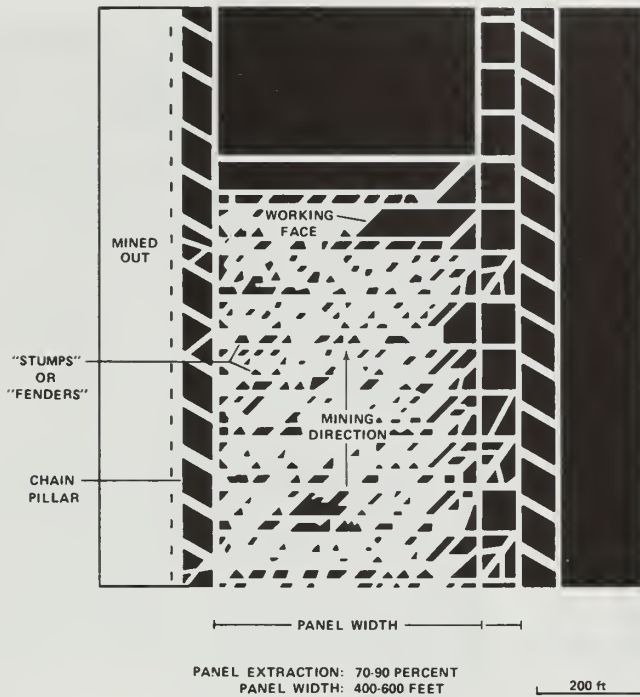
Figure 5c Modern method (high extraction retreat). Small stumps of pillars are left for safety. Chain pillars may be mined to increase panel width (after Hunt 1980).

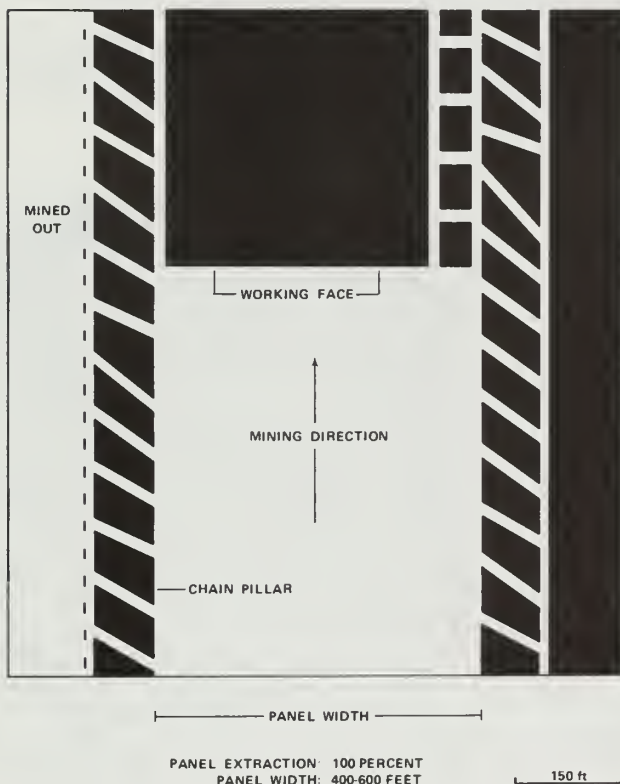
Figure 5d Modern method (longwall). All coal is removed along a straight mining face, thus forming a sharply defined panel with no remaining coal support (after Hunt 1980).

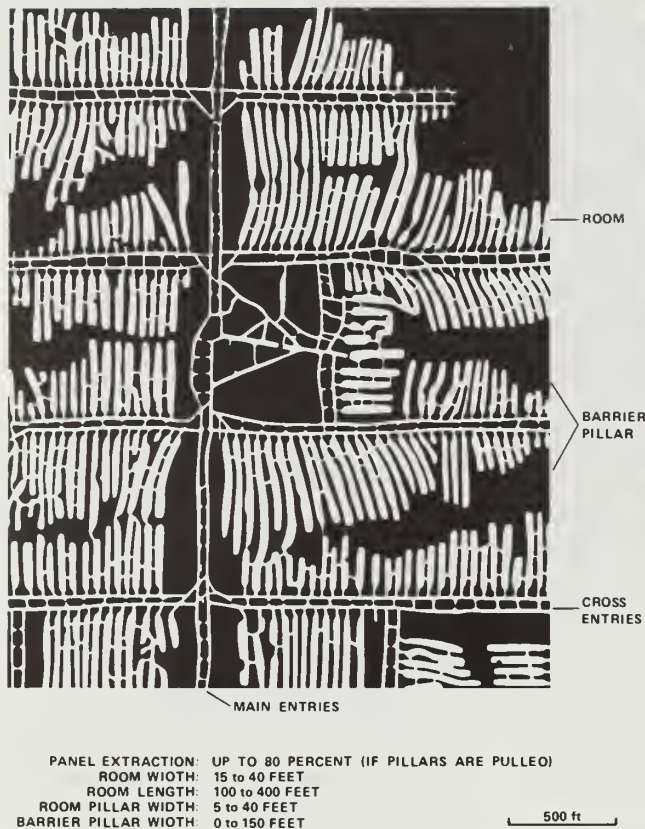
Figure 6a Early room and pillar mining method (basic). Irregular layout was typical of some early mines (after Andros 1914b).

The room-and-pillar method frequently used before the early 1900s was characterized by rooms that varied considerably in length, width, and sometimes direction (fig. 6a). To separate production areas (panels) from main entries (providing more support to the main entryways) and to improve ventilation, mine operators devised the modified room-and-pillar or panel system (fig. 6b). This system provided a more regular configuration of production areas. The rooms and pillars were set back from the main entries, and production areas (panels) had well defined boundaries as a result of the broad barrier pillars or unmined areas left between panels. Two room-and-pillar methods in current usage are the blind room and the checkerboard (figs. 6c-d). Using the first method, miners bypass every sixth or seventh room of a production area. The unmined area (blind room) functions as a large pillar to support the roof. This method is still used today. The checkerboard system has evenly spaced square pillars in a checkerboard pattern of panels 1,750 feet wide by 2,250 to 2,750 feet long. Modern room-and-pillar mines have many main and secondary entries to provide for required ventilation.

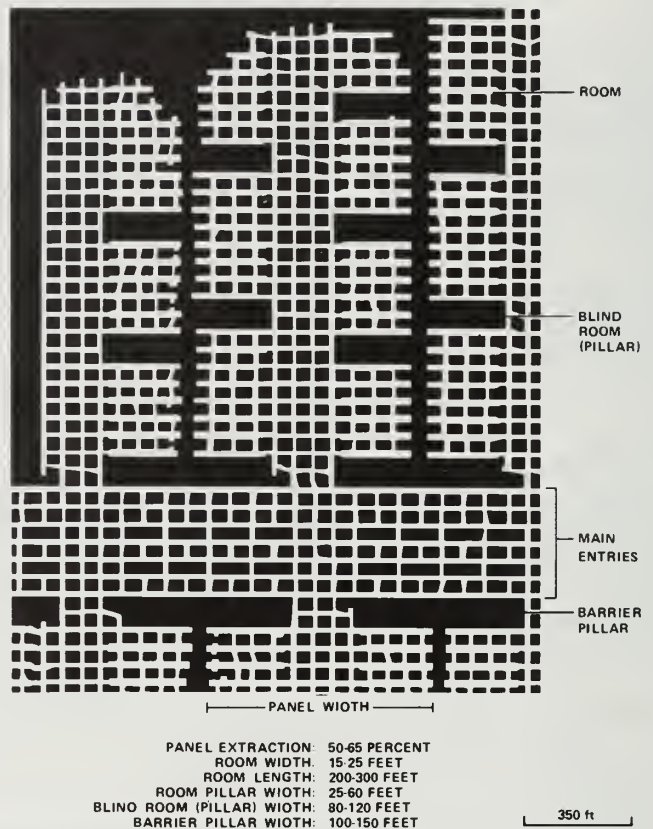
Figure 6c Modern method (blind room). Every sixth or seventh room within a panel is left unmined (blind) for additional support of the overburden (after Hunt 1980).

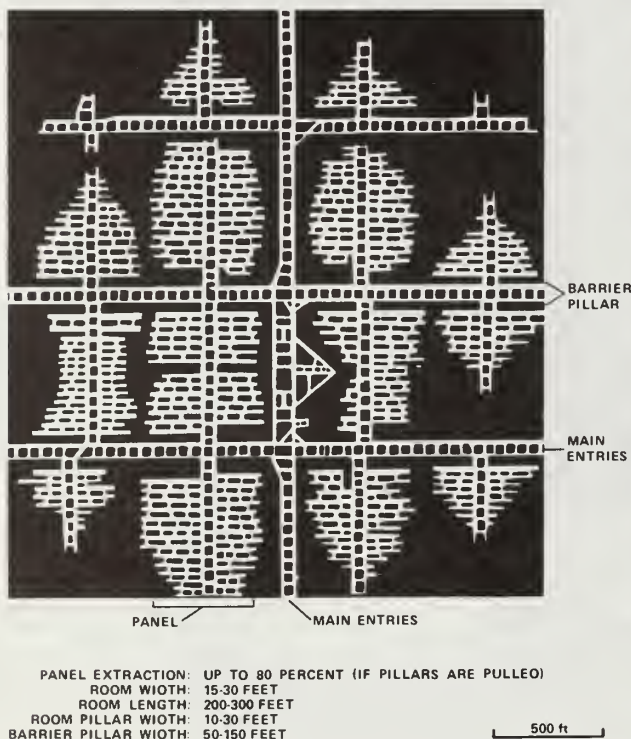
Figure 6b Early method (modified). More regular layout of rooms and pillars; panels were separated from main entries (after Andros 1914a).

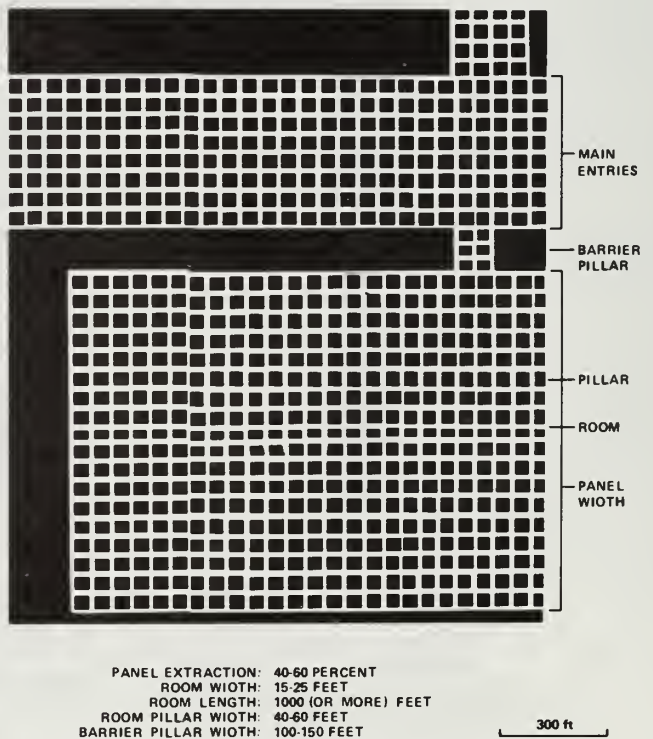
Figure 6d Modern method (checkerboard). Large, evenly spaced square pillars in a checkerboard configuration (after Hunt 1980).

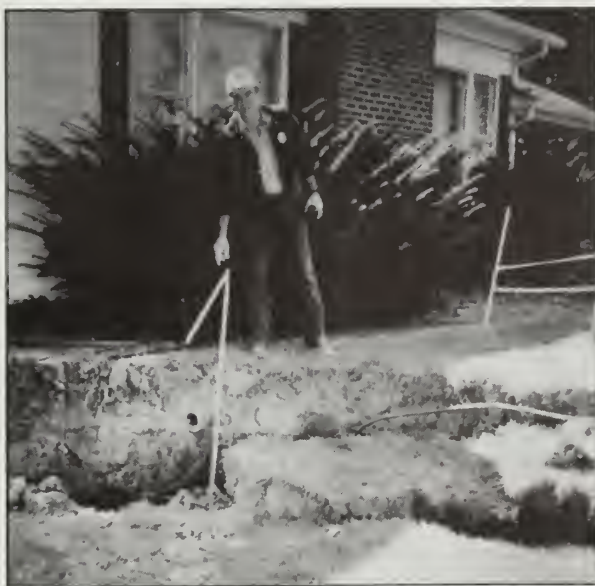
Figure 7 Photograph and cross section of a typical pit subsidence event (after Wildanger et al. 1980).

Pits are usually 6 to 8 feet deep and range from 2 to 40 feet in diameter (fig. 7), although most are less than 16

is low because most pits are relatively small, that is, only a few feet across. If pit subsidence develops under foundation walls, it may not immediately affect the house because the foundation temporarily bridges the pit (fig. 7). Eventually, the "bridge" may become damaged.

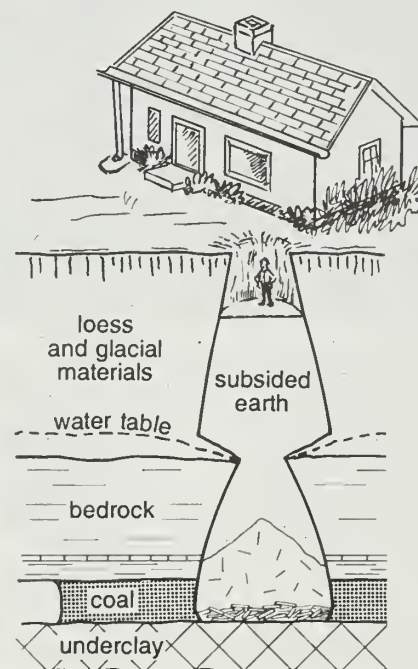
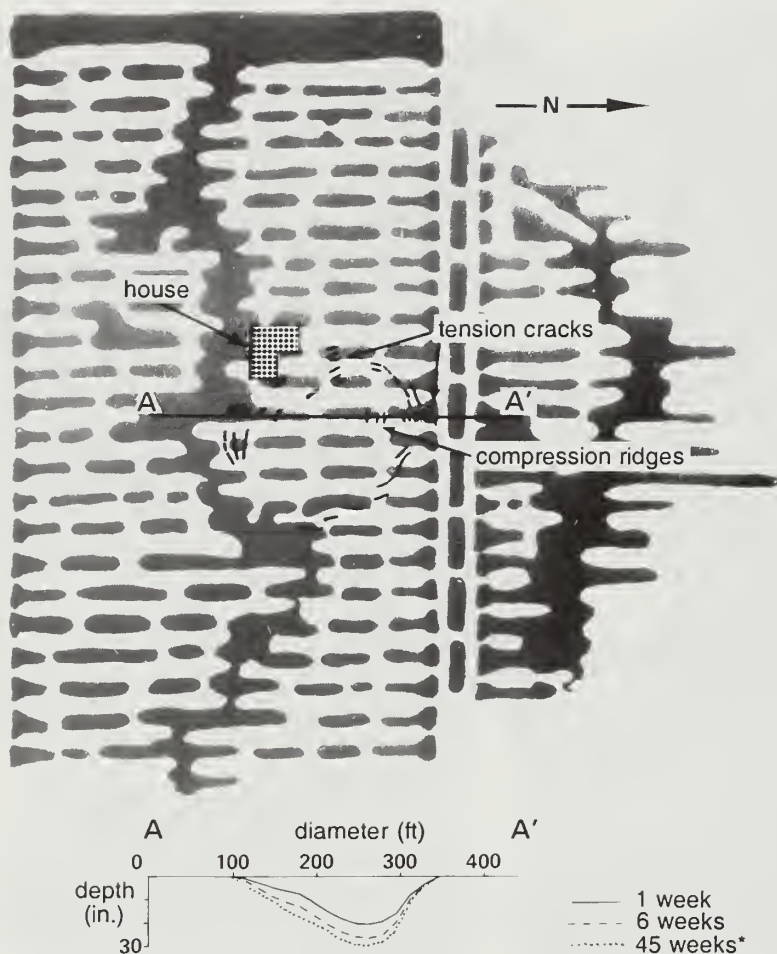
Figure 8 Sag subsidence shown on map of the underlying mine. Profile A-A' shows the sag developing. Compression ridges formed near the deepest part of the sag, and tension cracks formed around the perimeter. (*Data from Dave Kiesling, Department of Civil Engineering, University of Illinois, pers. comm. 1981.) See also figure 9.

Sag subsidence forms a gentle depression over a broad area. Some sags may be as large as a whole mine panel—several hundred feet long and a few hundred feet wide (fig. 8). Several acres of land may be affected. The maximum vertical settlement is usually 2 to 4 feet, as shown along the profile below the mine plan in figure 8.

A major sag may develop suddenly (in a few hours or days) or gradually (over years). The profile in figure 8 shows settlement that took place over 45 weeks.

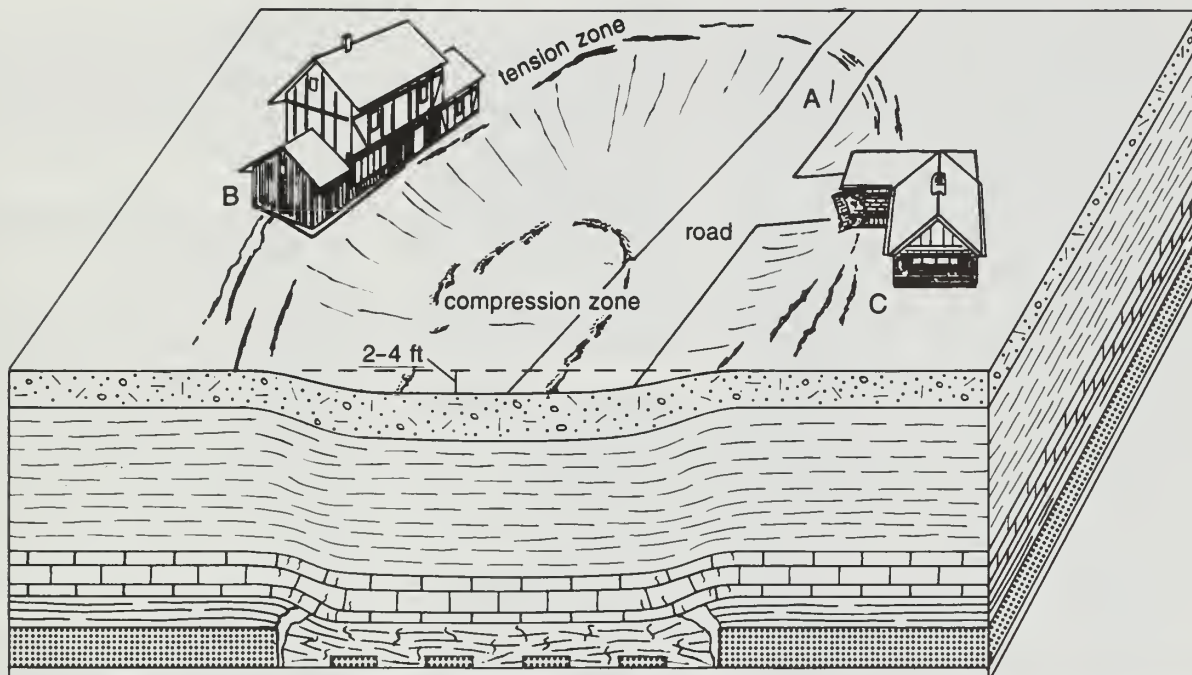
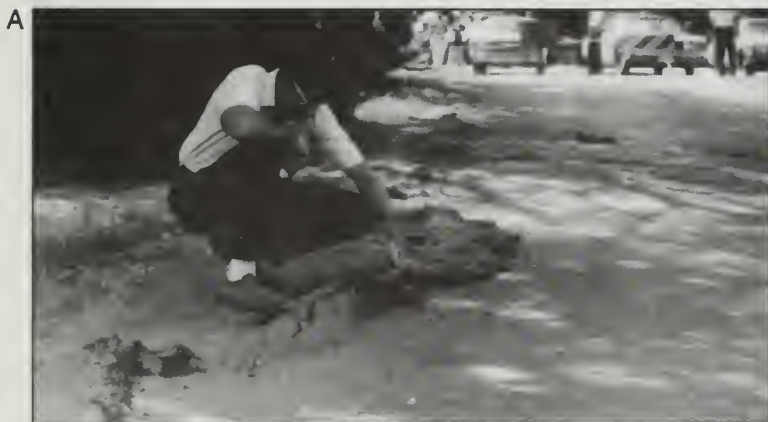
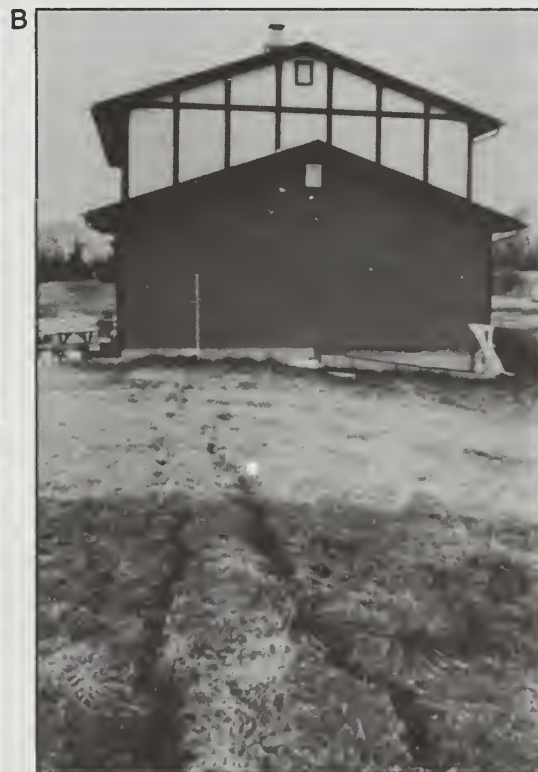
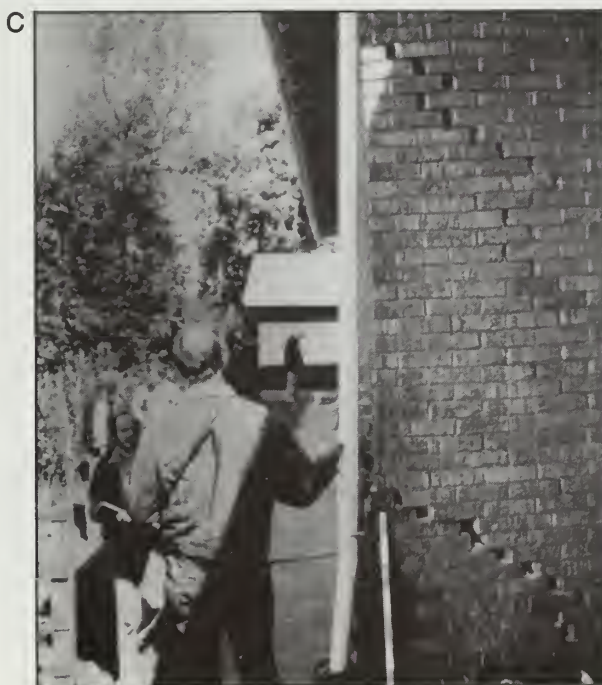
Figure 9 Block diagram and photos of a typical sag subsidence event. A. Road in compression zone. Asphalt has buckled. B. Wood frame house in tension zone. Foundation has pulled apart and dropped away from the superstructure in one corner. C. Brick house in tension zone. Walls, ceilings, and floors have cracked.

The ground moves in two directions during sag subsidence (fig. 9). It drops vertically and moves horizontally toward the center of the sag. At the surface, the sag may be much broader than the collapsed part of the mine. For example, a failure in a mine 160 feet deep could cause minor surface subsidence more than 75 feet beyond the edge of the undermined area. The deeper the mine, the larger the area affected.

In the comparatively smaller compression zone, roads (A) may buckle and foundation walls be pressed inward. The foundations of any houses in the center of the sag would be under horizontal compression. Although

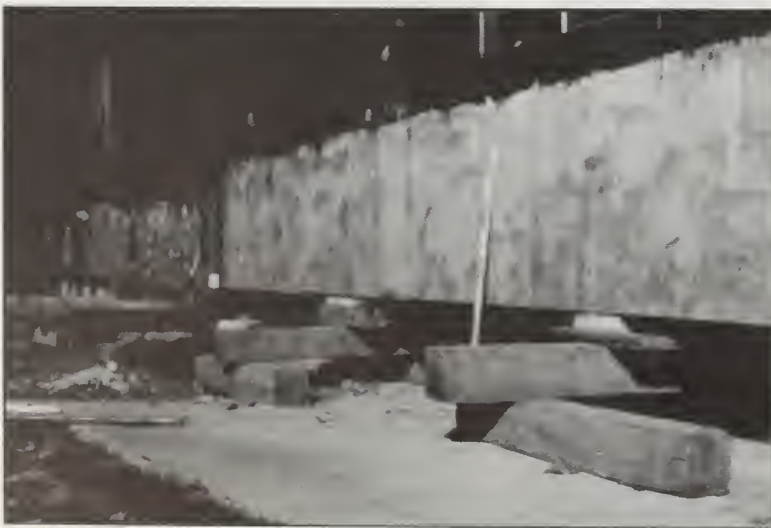
Figure 10 Bearing walls of a house on a slab. The entire superstructure has been jacked up to a level position, exposing the interior.

Restoring such a house to a level position may require detaching the house from the slab and jacking up the frame. Bolts that hold the frame to the slab can be difficult to find and remove because they are located in the walls. The load-bearing walls must be supported and jacked up because the typically constructed slab cannot be jacked up without causing severe damage.

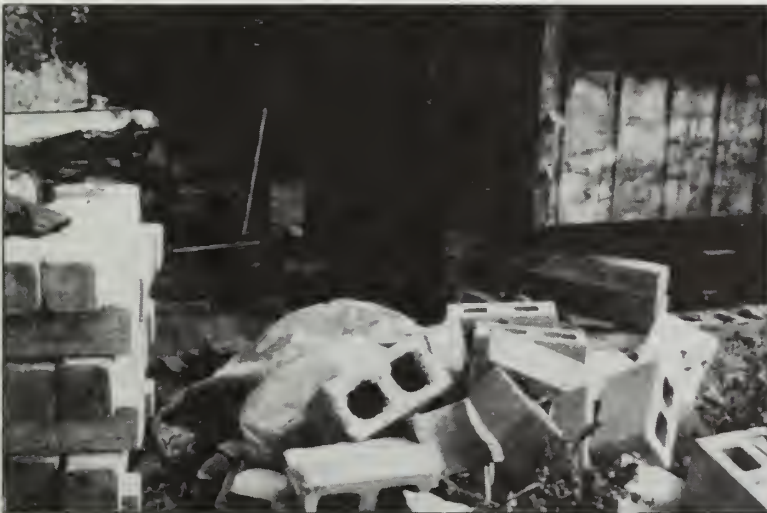
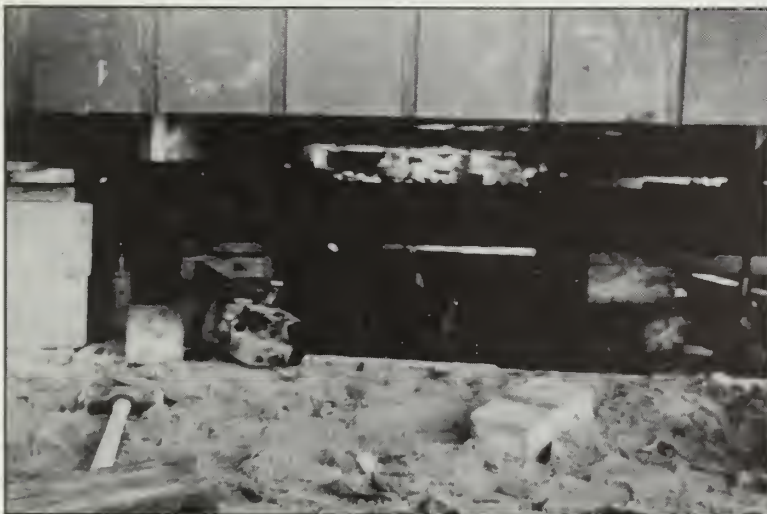
Figure 11 (above) Concrete blocks of a crawl space have been removed to make room to jack the house to a level position. (below) A closer view of the crawl space shows the I-beams supporting the relevelled house.

between the floor and the ground surface. Bolts attaching the foundation to the wood frame are generally accessible. Once the house is detached from its frame and support beams are placed under it, it can be jacked to a level position. Blocks from the walls of the crawl space are easily removed so that the beams can be inserted (fig. 11).

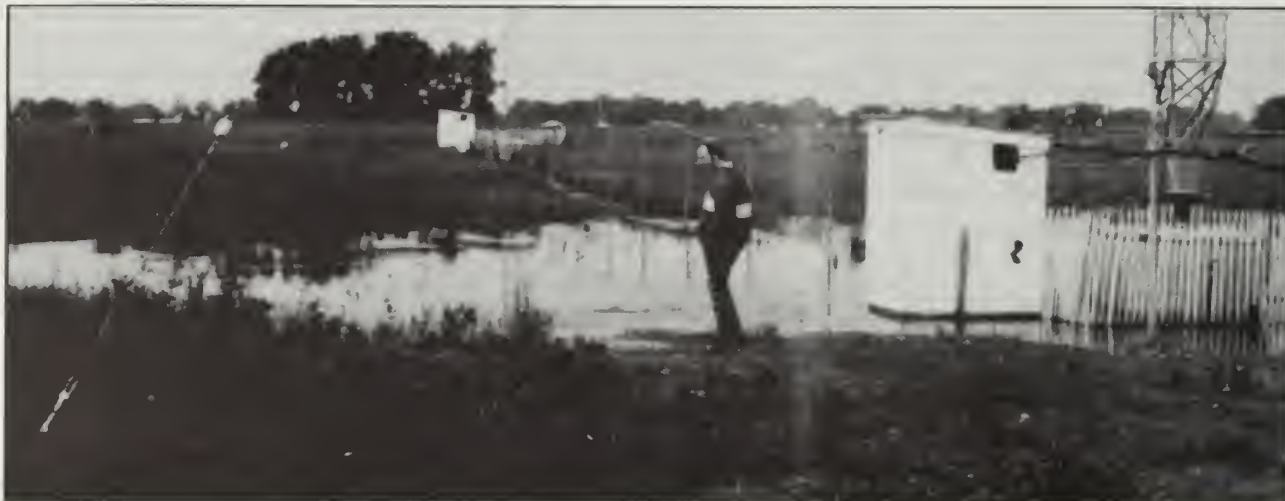
Figure 12 Ponding created by sag subsidence.

Water can also pond in a sag (fig. 12). If any part of a house is in a sag, an attempt should be made to keep the area under it dry. Also, the ground surrounding the foundation must be kept well drained because excess moisture can cause additional foundation-bearing problems.

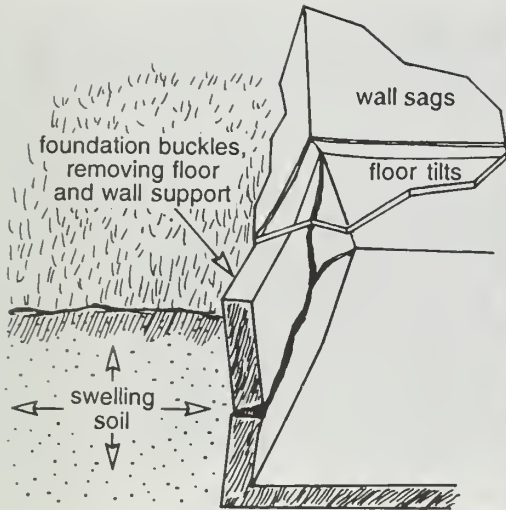
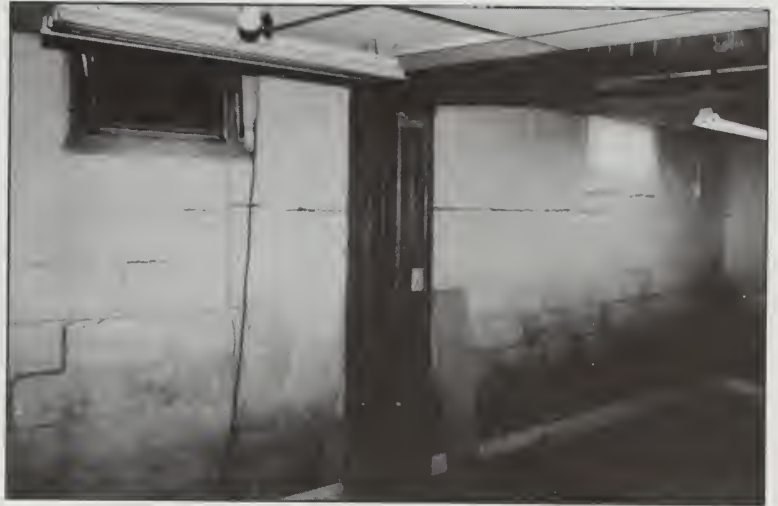
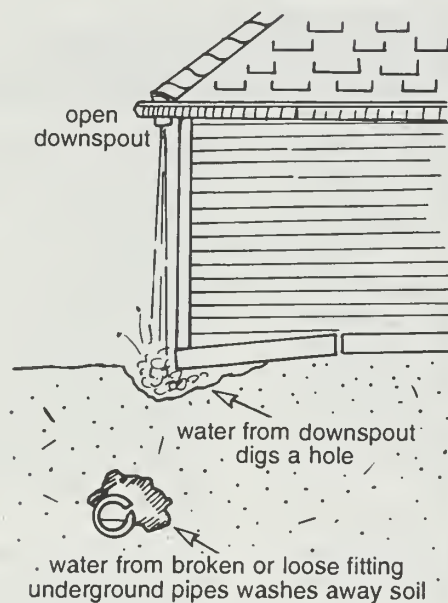
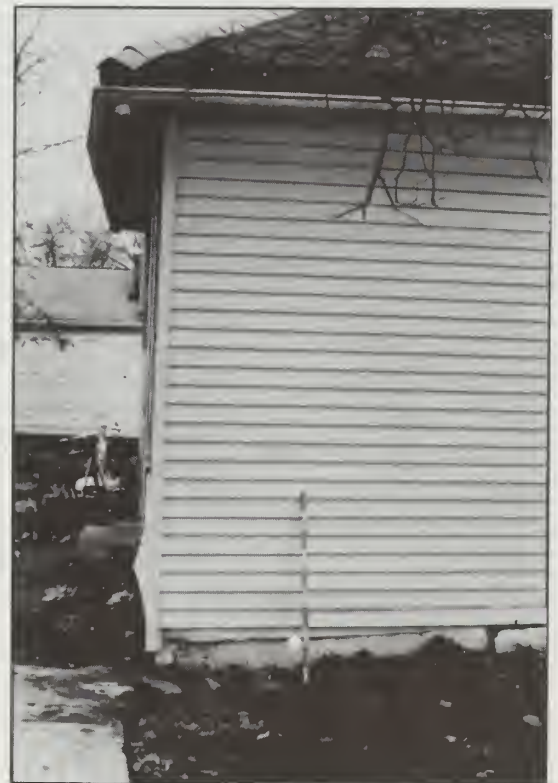
Figure 13 Examples of damage that may be mistaken for mine subsidence. (above) Shrink-and-swell and/or freeze-and-thaw cycles damage a foundation. (below) Water washes supporting soil from beneath a floor slab.

Shrinking and swelling Moisture-sensitive soils expand when wet and shrink when dry. Many decades of cyclic wetting and drying build up pressure against foundation walls, as soil and other debris fall into the space between the foundation wall and the dry, shrunken soil. As the walls press inward, the floor of the house may drop and tilt (fig. 13).

Loss of load-bearing support can cause foundations to tilt or sink (fig. 13). To avoid problems, homeowners should take measures to keep water away from foundation walls. Downspouts should discharge water several feet from the house. The earth should be built up and graded to slope away from the foundation so that water will then drain away from the house.

Freezing and thawing As some poorly drained soils freeze and thaw, they expand and contract in a manner similar to moisture-sensitive soils (fig. 13). Proper drainage through the use of granular materials (sand, for example) can reduce the potential for frost heave. These materials should be used beneath unheated outbuildings, driveways, retaining walls, and other structures that are most likely to be affected.

Piping Piping, or subsurface erosion from water washing away fine-grained soil, can occur along broken or separated sewer lines, water lines, and downspouts (fig. 13).

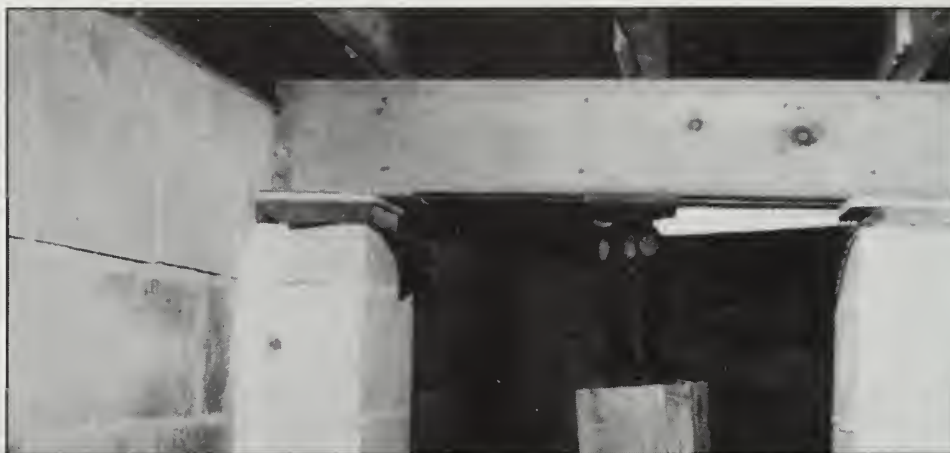
Figure 14 Main beam is not attached to the foundation. Because of differential settling, cracks develop in the house above the beam.

columns, they usually become compressed, thus lowering the beam (fig. 14). The ends of the main beam should rest on the foundation walls to reduce the likelihood of the beam moving a different amount than the foundation and causing cracks to develop in the walls above.
